Engine cylinder head and injector refurbishment and damper plate replacement

Patrick Carroll K00284933

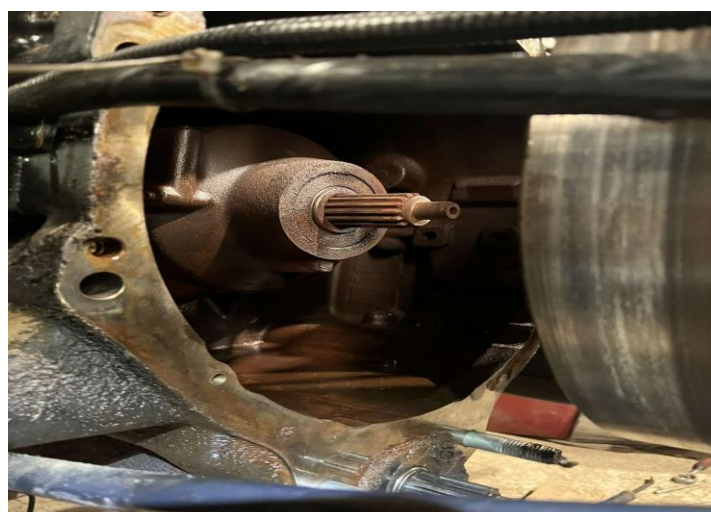
Picture of the input shaft going to gearbox

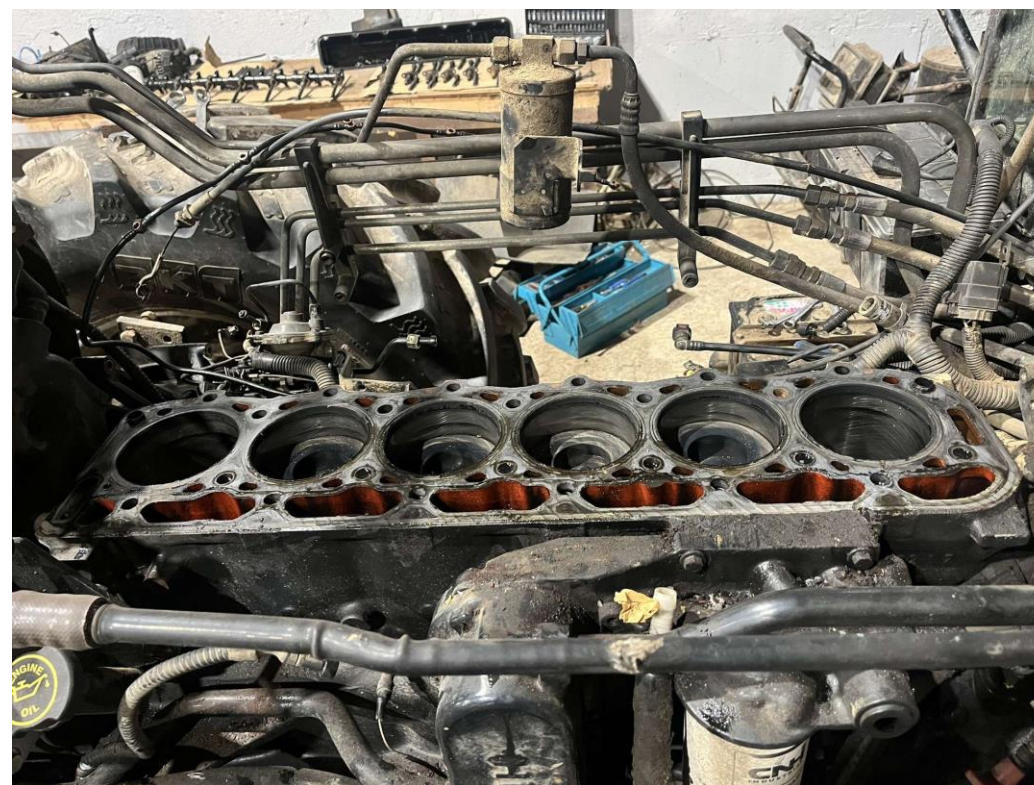
Picture of case mxm with the engine cylinder head removed

The first process of my project was to get the engine cylinder and injectors removed from the tractors engine. This involved taking off all the air filters, diesel filters and exhaust brackets. This took a lot of time and work. Once I had them parts off I was able to send the engine head and the 6 injectors away to engine re in co mayo who specialise in this work.

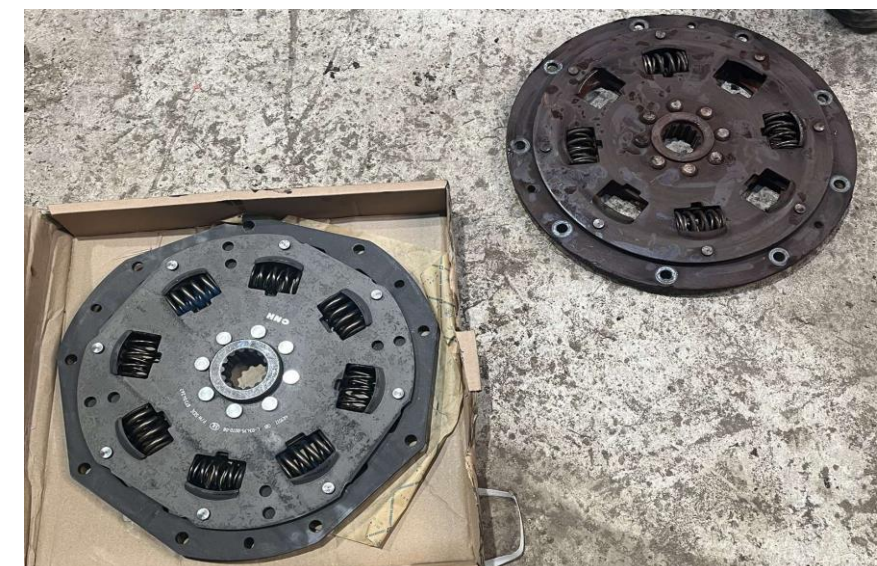
The next step in the project was to split the tractor to allow access to the damper plate. The tractor was split at the bell housing and rolled apart. There was 8 bolts holding the tractor together on the bell housing. The starter was also removed. The tractor was then jacked at the front and at the back and rolled out. Upon inspection it was found that the damper plate was broken as there was 4 springs that had fallen out of the damper plate. If another spring had fallen out, then there would be no drive transmitted to gearbox.

In the picture above, you can see that there are springs missing from the old damper plate. The new damper plate was put onto the flywheel and I rolled it back together and all the hard ware put back together.

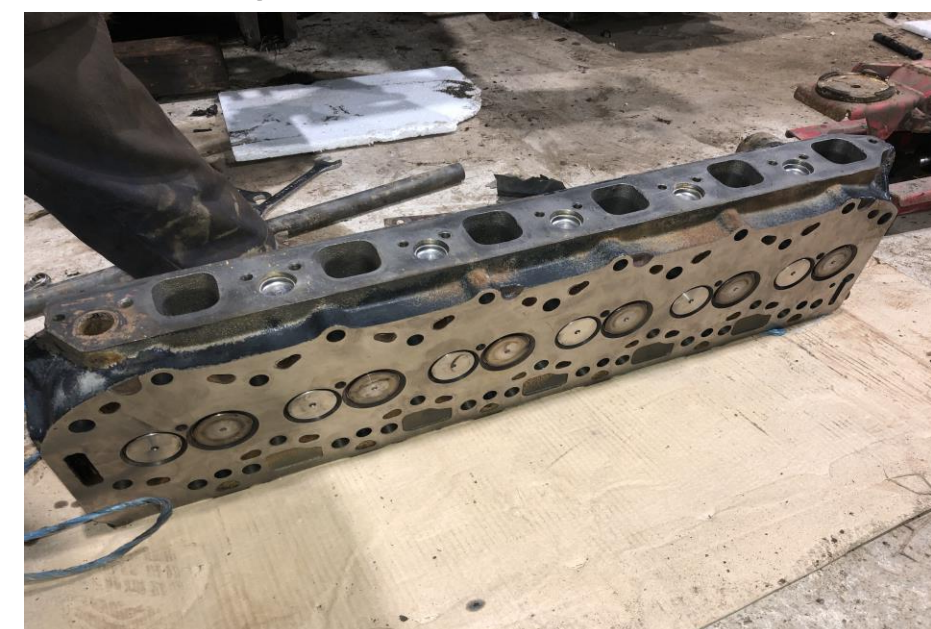
Picture of bottom of engine head after resurfacing

To rebuild the head, Engine Re machined the suraces, fitted new valve seats, valve guides, collets, springs, valves and cleaned it out. They also refurbished the 6 injectors. The cost of this was 1500.00 euro. The parts I acquired myself were the damper plate, seals for water pump, gasket for water pump, head gasket set, rocker cover seal, exhaust gasket, exhaust manifold bolts and damper plate bolts. The price for all these parts came too 890 euro. These parts were sourced off WR shaw in Tullamore Offaly

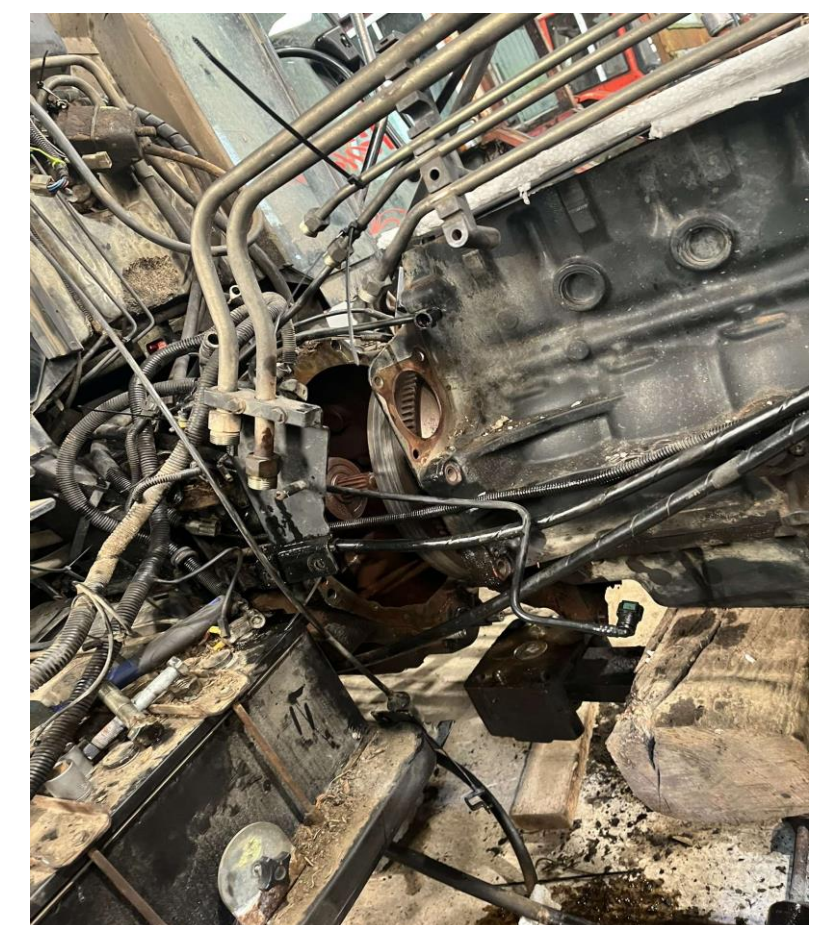
Picture of tractor split at bell housing
