Shea Dunworth

## Aim of the Project

The Aim of the project is to use the DMAIC method to identify and resolve scrap causes in the Drag Finishing process at Croom Medical

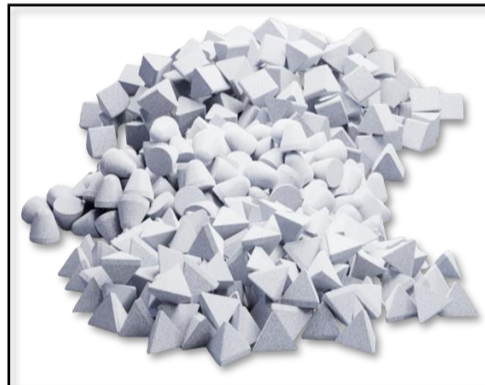
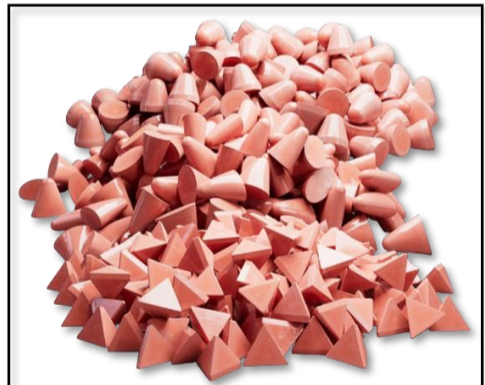
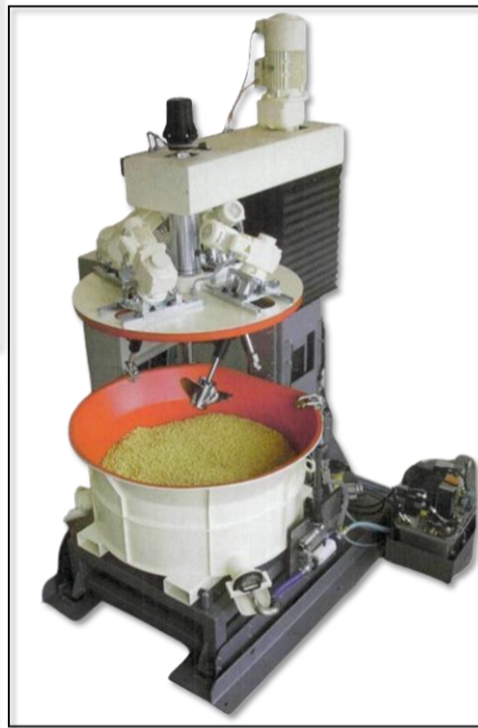
Drag Finishing is a type of mass media finishing. Components are attached to a spindle that rotates and "Drags" the part through a bowl of media. The media particles makes thousands of tiny scratches on the surface of the component. If the media is coarse, it will give the component a rougher surface finish, smoother media will give a smoother finish. It is a similar process to grinding operations.

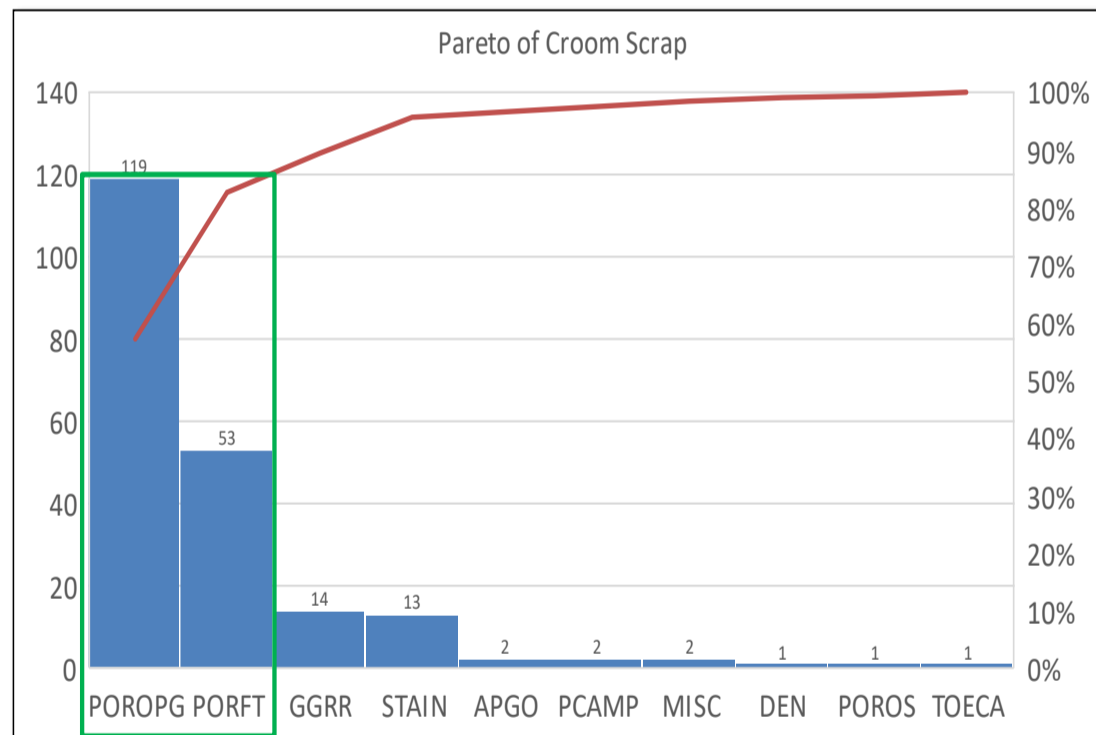
The Scrap quantity for a 30-working day period of high-volume production was analyzed. It was found that the Scrap Codes for POROPG and PORFT accounted for 90% of all scrap produced. This was discovered using Pareto Analysis.

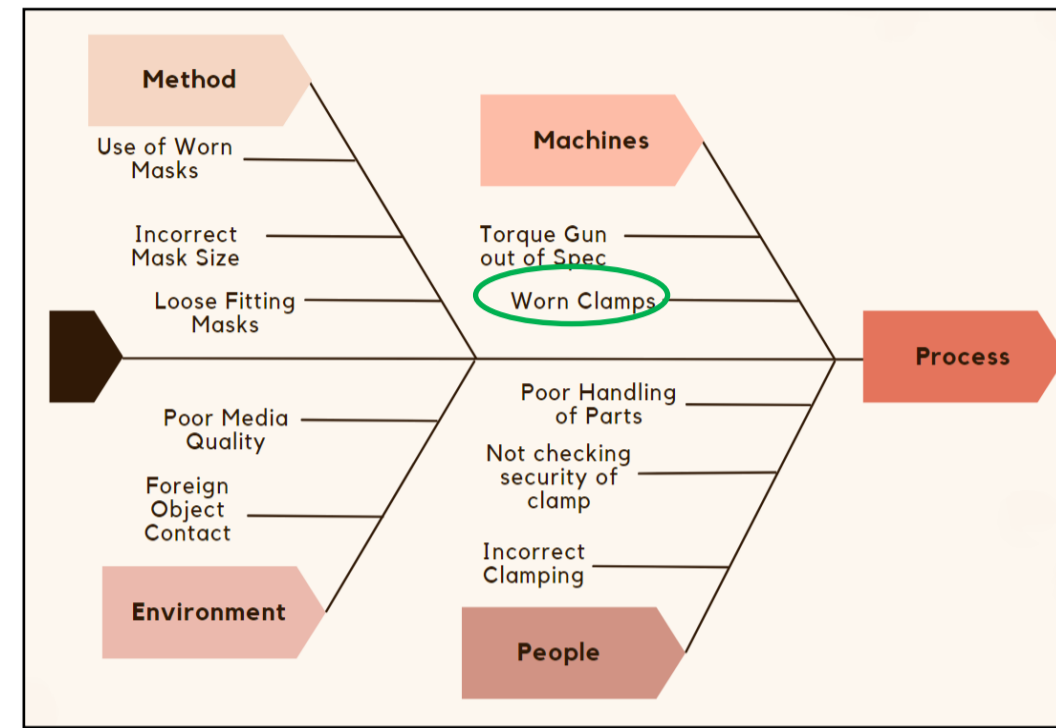
A Cause-and-Effect diagram was constructed to Root-Cause the POROPG issue. This contained all the potential causes of scrap. An investigation was then carried out to determine the validity of each of the possible causes. It was determined that Worn Clamps was the root cause of the POROPG Scrap.

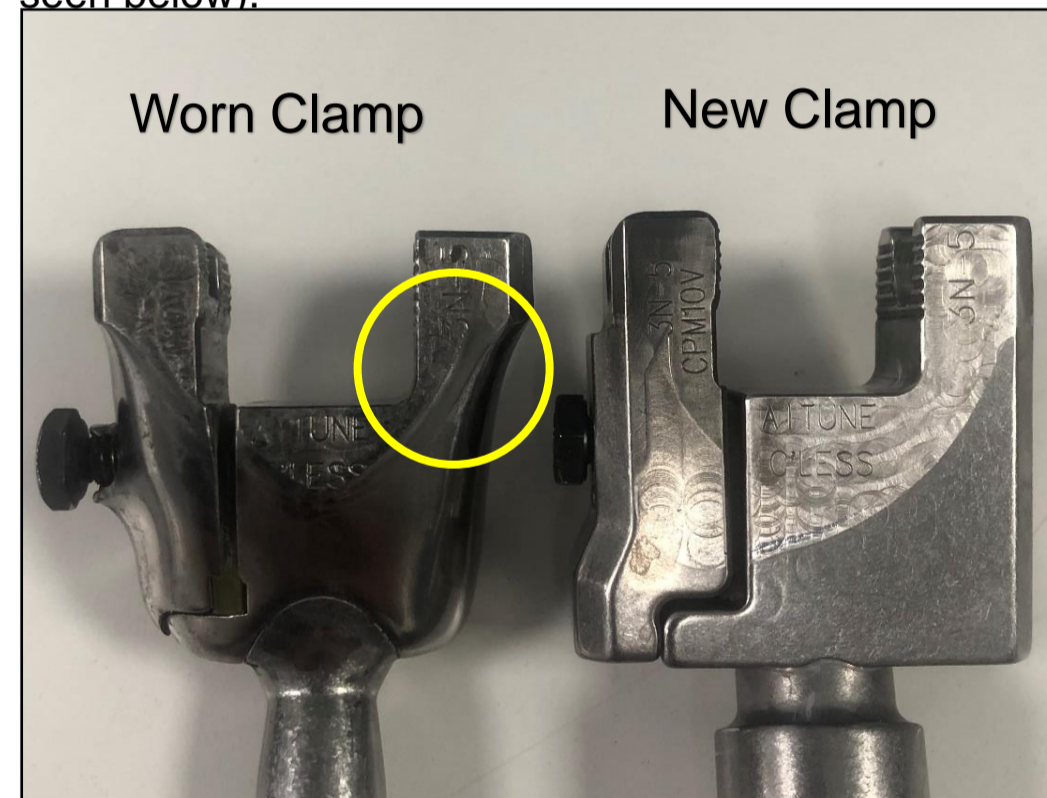
The difference between a worn clamp and a new clamp was quite apparent once compared side by side (as seen below).

This excessive wear allowed for media to ingress and damage the Critical-to-Quality surface on the internal face of the component. A wear gauge was created to determine which clamps were acceptable to production. This gauge checks the dimension of the area highlighted in yellow above. All worn clamps were removed from the production floor. This gauge check was then added to the daily ECC's.

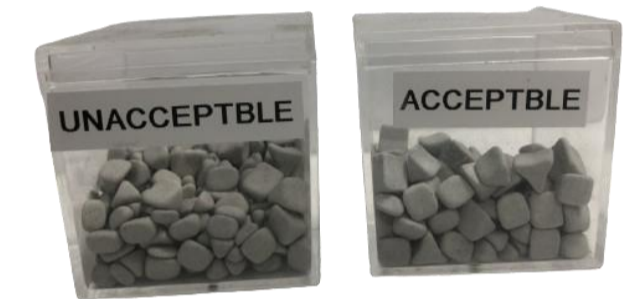
A 5 Why's Analysis was carried out in order to Root Cause the PORFT scrap code. The result of this was "No check for media quality present in SOP's or ECC's". The related SOP for media sieving was updated to reference the media quality as the indicator to sieve the bowl. This quality check was also captured in the Equipment Condition Checks that the operators perform daily. A visual aid was created to better defined acceptable and unacceptable media quality.

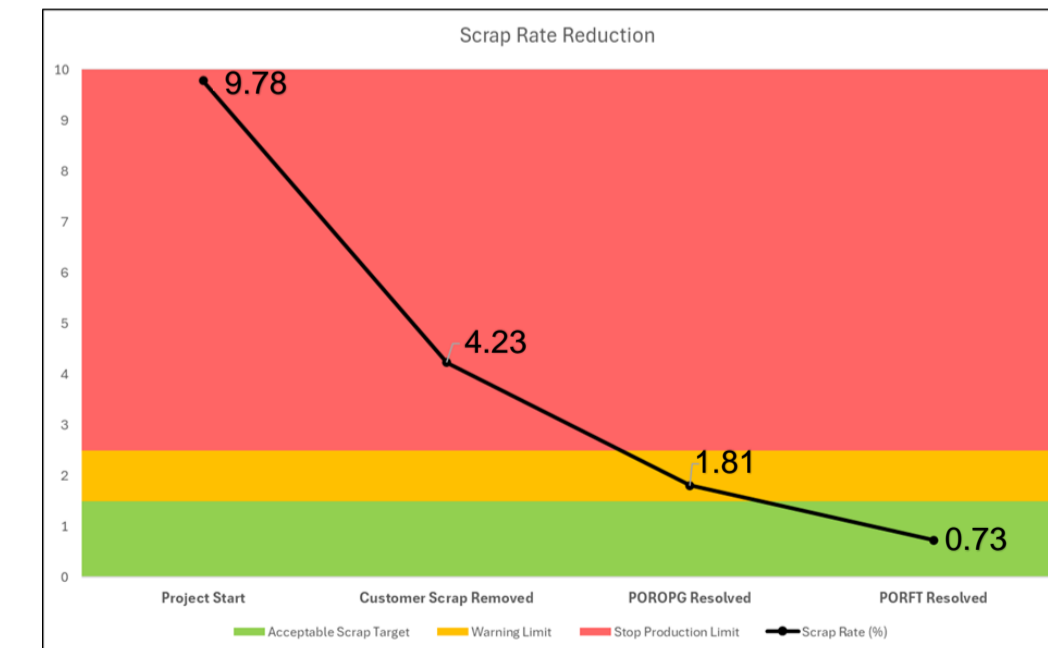
When customer scrap was removed from the total scrap count, the scrap rate was reduced to 4.23%. This reflected the scrap for the Croom Value Stream. When the POROPG scrap was root-caused and addressed, the scrap rate reduced to 1.81%. When the PORFT scrap was addressed, the scrap percentage of the process was said to be 0.73%.
